## RAILROAD ACCIDENT REPORT

FIRE ONBOARD AMTRAK PASSENGER TRAIN  
TRAIN NO. 11, COAST STARLIGHT  
GIBSON, CALIFORNIA  
JUNE 23, 1982

NTSB / RAR-83 / 03

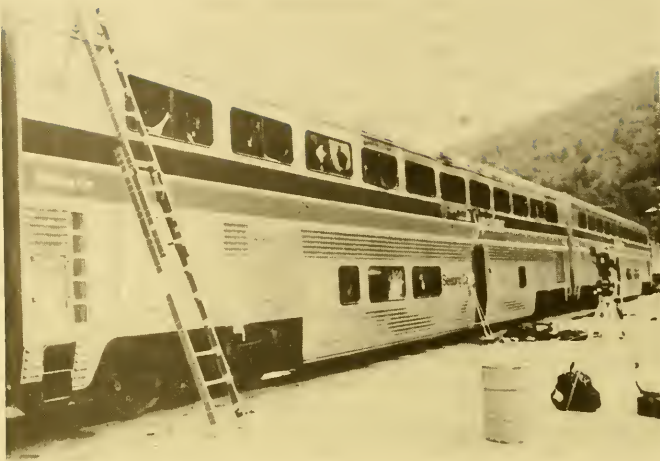
The upper level of sleeper car No. 32010 (1130) was destroyed; the lower level was damaged by the intense heat and smoke. (See figures 6, 7, and 8.)

Figure 6.--Exterior view of the 1130 car.

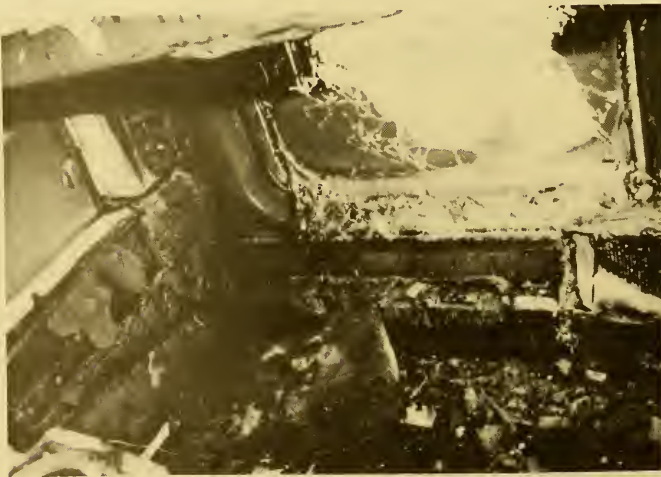
Figure 7.--Interior view of burned economy-type bedroom in the 1130 car.

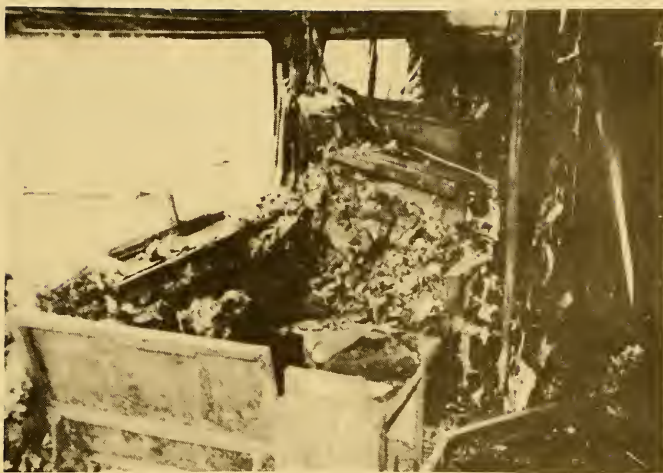
Figure 8.--Interior view of burned economy-type bedroom in car 1130.
